From: "Ted Atkins" <tedatkins@gmail.com>
To: <undisclosed-recipients:>
Sent: Saturday, April 07, 2012 8:26 AM
Subject: Kathmandu Oxygen Explosion

From: "Ted Atkins" <tedatkins@gmail.com>
To: "Ted Atkins" <tedatkins@gmail.com>
Sent: Friday, April 06, 2012 8:26 AM
Subject: MORE SERIOUS OXYGEN EXPLOSION IN KATHMANDU

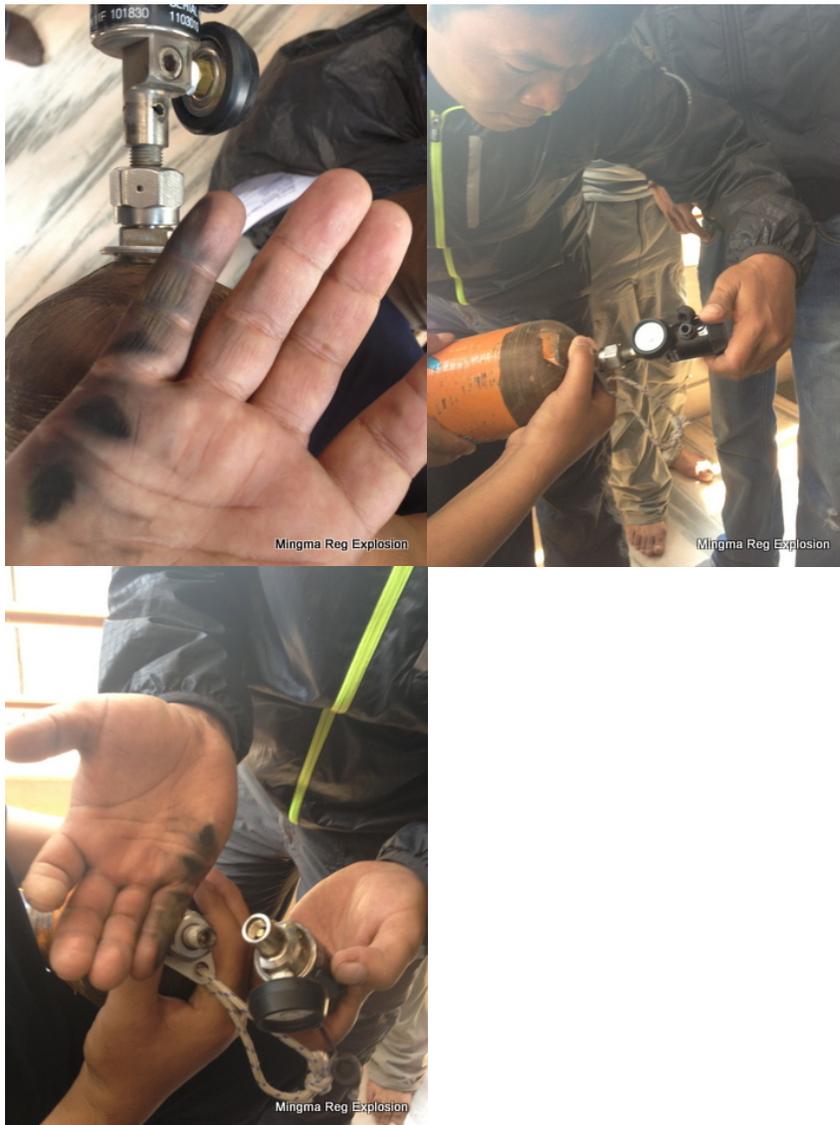
Mingma Sherpa of Seven Summits earlier emailed the attached photos. While attaching a Summit regulator to a Poisk cylinder for the first time the regulator exploded.

Flames erupted and he ended up burnt. He persisted and disconnected the regulator and made the situation safe. He then asked to come and see me with the regulator. The metal case is burnt through in two points. This is different and potentially more serious than the previous accident as this was an ignition.

I quizzed Mingma extensively if it was at all possible that either item had come into contact with oil, grease or paraffin. He is adamant this could not be so. We have to trust his judgement, he is very experienced in this field.

I have passed what I know to Summit Oxygen and await a response. Meanwhile please be careful. Mingma was not wearing gloves or any other safety equipment. This would have saved or reduced the burns to his hands. It could be said that he has been lucky! Until Summit get back with a definitive response please use your best judgement. I will keep you informed of any new developments as I have them.

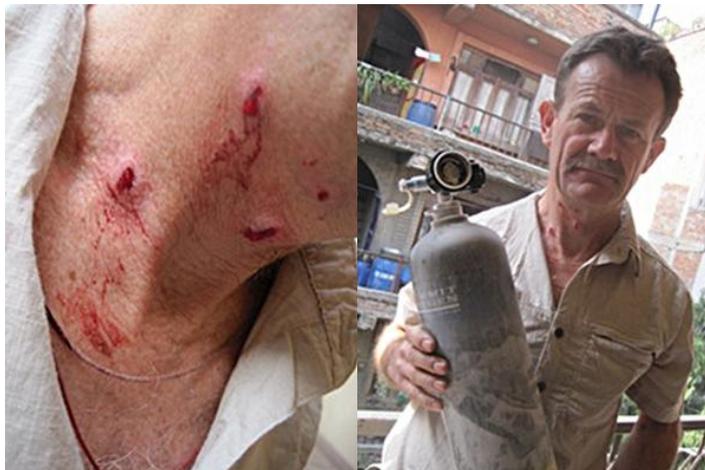
"News travels fast of an accident and I would like to explain the facts as we know them today. I was injured testing a Poisk regulator in conjunction with a new Summit cylinder yesterday. I chose to use the new cylinder because it was a new introduction to climbers

The regulator that failed was not an old style nor was it the newest style. As I fastened it onto the cylinder there was an explosion. I had pieces from the gauge embedded in my neck (I am grateful to Kaju from Asian Trekking for taking this out with a pair of pliers).

It could be that this was simply a 'one off' defective regulator, but I have fitted so many in my time and this is a first for me and the first I have heard of. I was VERY lucky to get away with the level of injury I received so until this situation is resolved PLEASE observe the precautions I have listed.

- Wear ski goggles when changing the regs
- Wear gloves
- Put the cylinder onto the regulator keeping the regulator in the same plane with the gauge pointing at the ground.
